Monitoring Data Record

Project Title: R-2417BA (Sites 14 and 22) COE Action ID: 2002-2-0899  
 Stream Name: UT Bull Run DWQ Numbers: 001432  
 City, County and other Location Information: Lee County, US 421-NC 87 Sanford  
 Bypass from East of US 1-15-501 to East of SR 1521  
 Date Construction Completed: Site 14 (May 2003) & Site 22 (April 2004)  
 Monitoring Quarter: ( 8 ) of 8  
 Ecoregion: \_\_\_\_\_ 8 digit HUC unit: 03030004  
 USGS Quad Name and Coordinates: \_\_\_\_\_

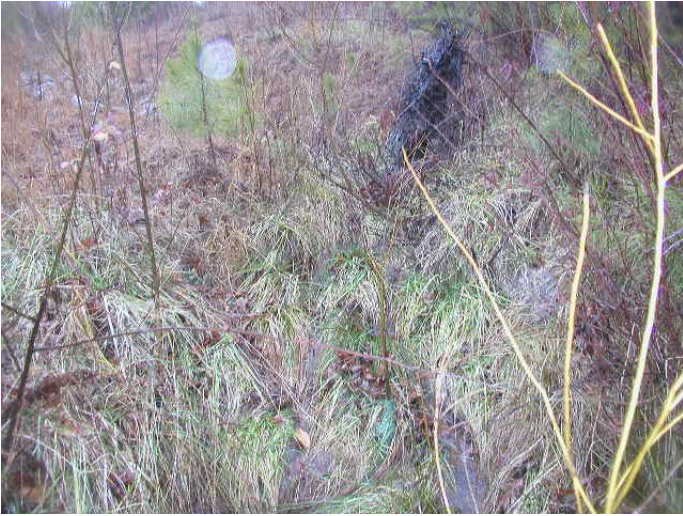
Photo 1

Site 14 stream relocation at Sta. 133+90 LT. has a slight headcut where the relocated stream ties back to the existing stream. The stream relocation is stabilized.

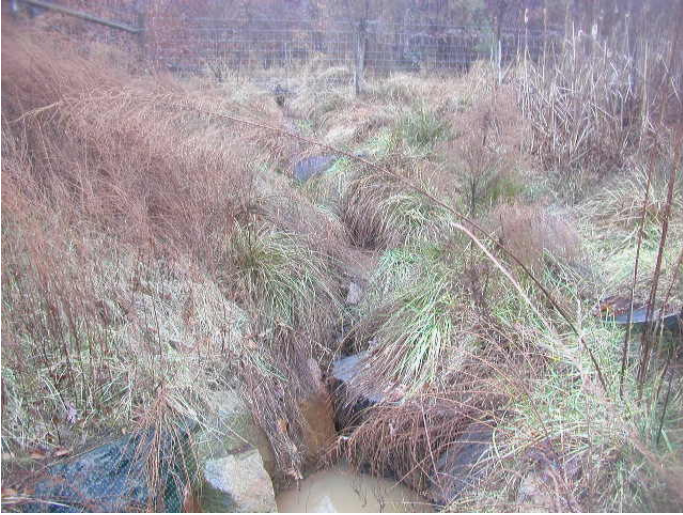
Photo 1

Site 22 stream relocation at Sta. 146+00 RT. has two cross vanes that were constructed without filter fabric per the plans. Water is currently flowing through the structures. There has been some localized erosion but the site has stabilized with vegetation. NCDOT proposes to discontinue channel stability monitoring at Sites 14 and 22.
